# **Dam Safety Assessment of CCW Impoundments**

## **Gallagher Generating Station**

**United States Environmental Protection Agency  
Washington, DC**

**April 7, 2011**

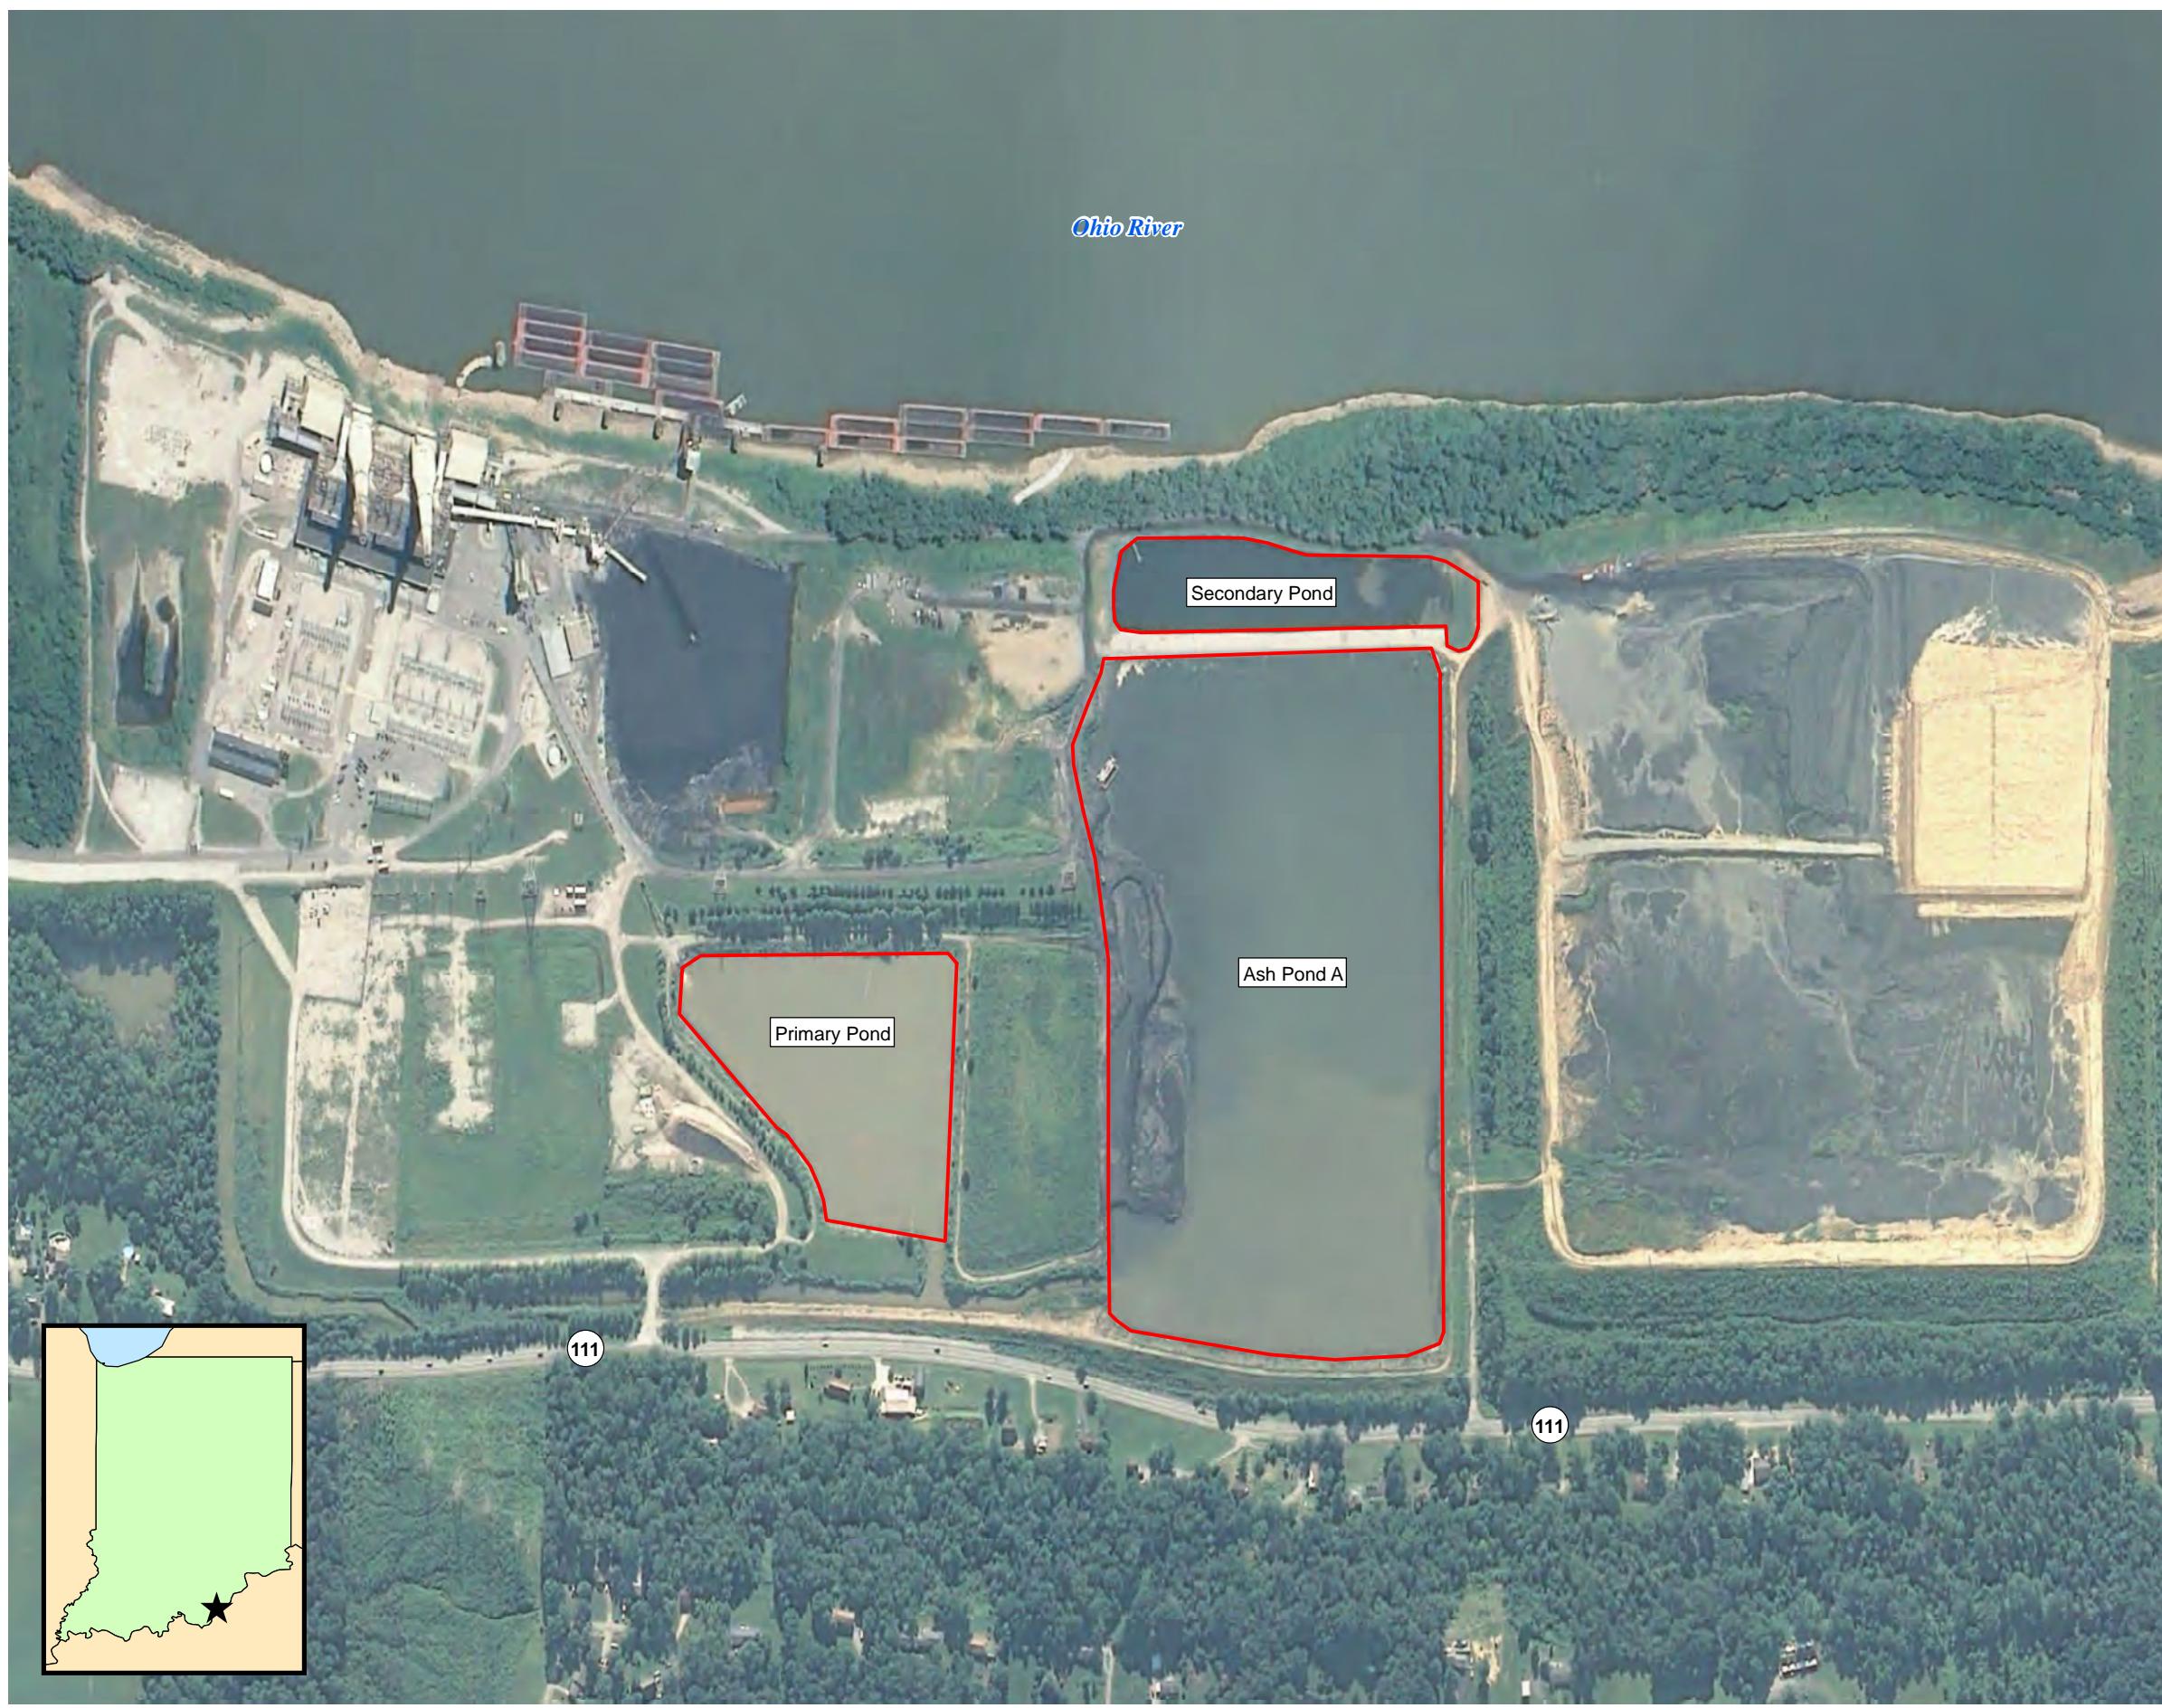
**FIGURE 2**

The three contiguous impoundments inspected during this safety assessment are identified on Figure 2 – Facility Layout Plan. None of the impoundments are regulated as dams by the Indiana Department of Natural Resources (IDNR).

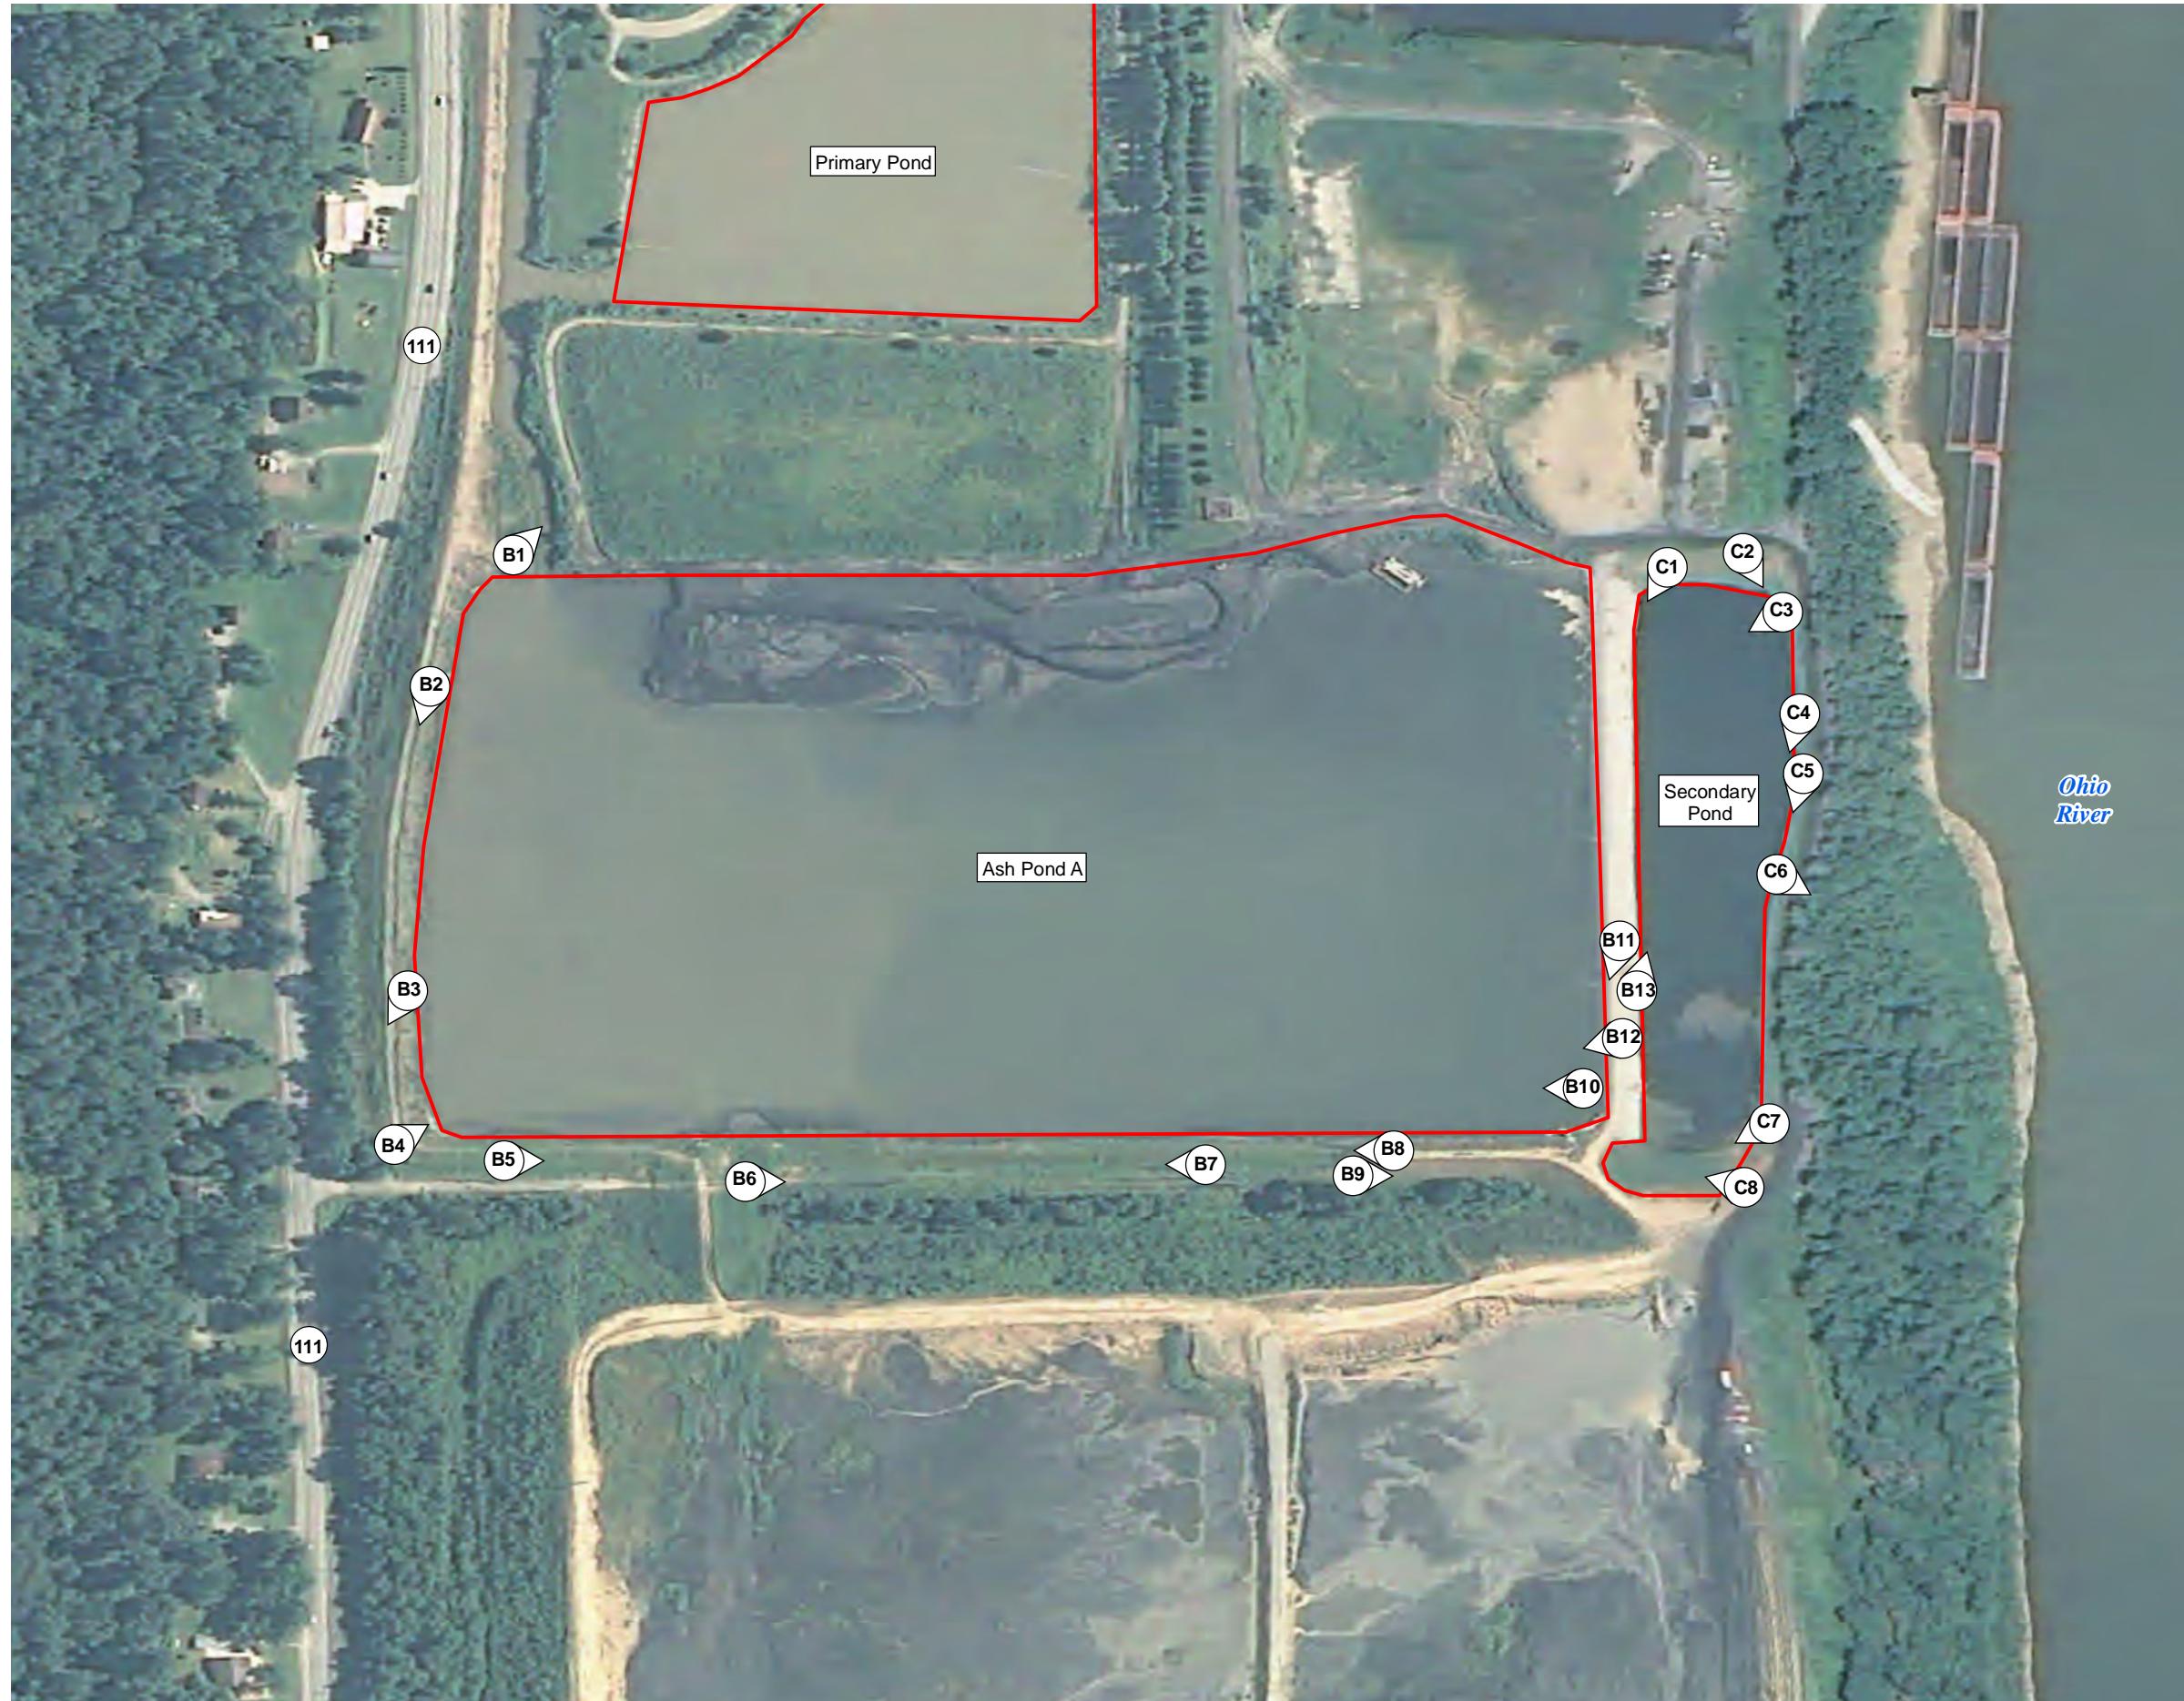
**FIGURE 3**

Photographs of relevant features and conditions observed during the inspections were obtained by O'Brien & Gere and are provided in Appendices B and C for Ash Pond A and the Secondary Ash Pond, respectively. Site Plans of these ponds are presented as Figures 3 and 4, which also provide photograph locations and directions.
